Report for

AMERICAN ACADEMY OF PHYSICAL MEDICINE & REHABILITATION

WALK-THRU ACCESSIBILITY INSPECTION OF

- A. MUSIC CITY CENTER CONVENTION FACILITY.
- **B. CONTRACTED HOTELS SERVING CONVENTION FACILITY.**
- C. ACCESSIBLE ROUTE TO MUSIC CITY CENTER FROM CONTRACTED HOTELS.

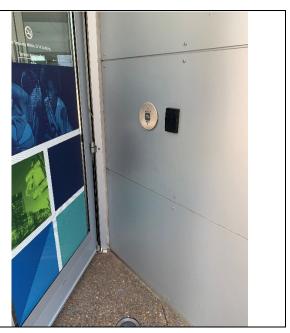
Auto door opener at Level 1 official entrance located within outward door swing. Person in wheelchair can get hit by door swing. Opener needs to be relocated out of door swing.

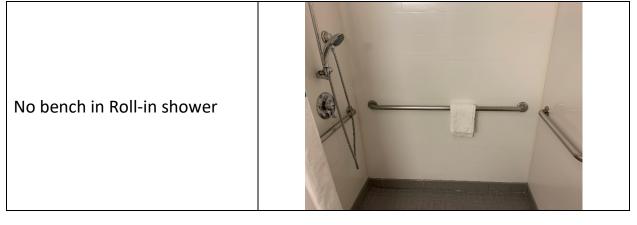
Non-Compliant item/(s): HC guest room checked:

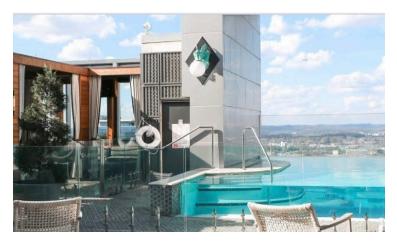
Roof top bar has no accessible portion of bar. See photo	
No lift at pool – stair entry only	
Accessible guest room curtain pulls above 48", staff was informed of this issue.
